Conservation Appraisal for  
Lismore Parish Church, Lismore

Munro Allison Architects, Edinburgh

March 2024

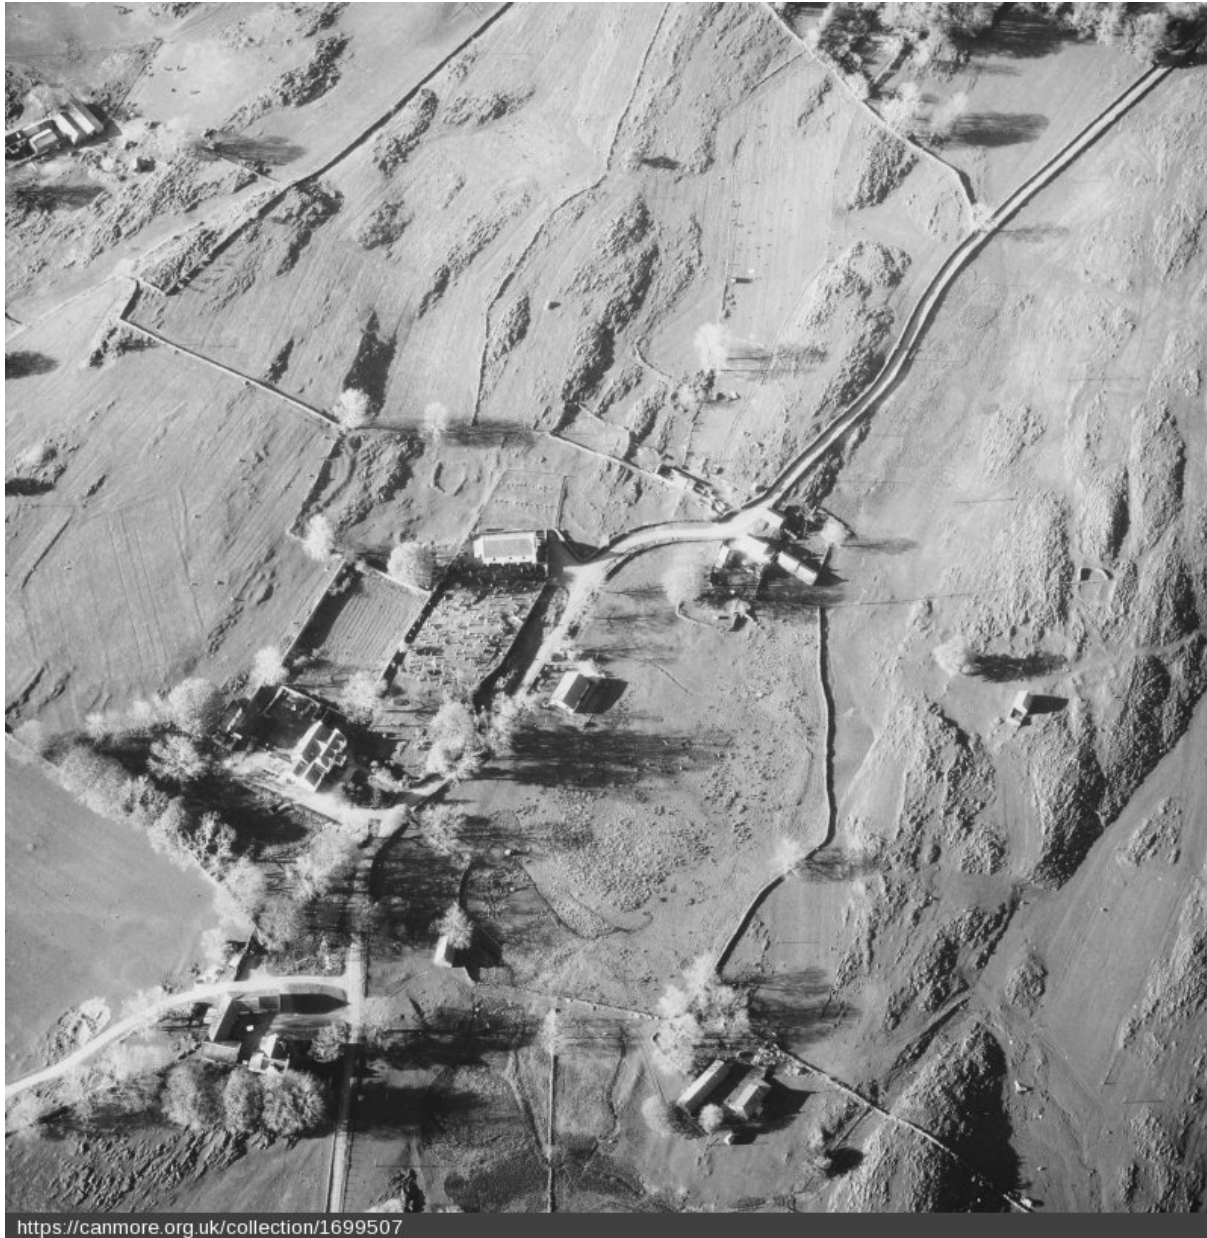
Fig 1: Aerial photograph of Lismore Parish church and environs

The Church sits within a small, divided enclosure, within a landscape of farmland. The church 'land' is surrounded on three sides by graveyard (although these are owned by Argyll and Bute, not the church) with the east edge bounded by the main road. Beyond the immediate graveyards, there is another remnant of enclosure, possibly of the earlier glebe or vallum, which also includes land to the south east of the site and the old manse and garden (fig.1)

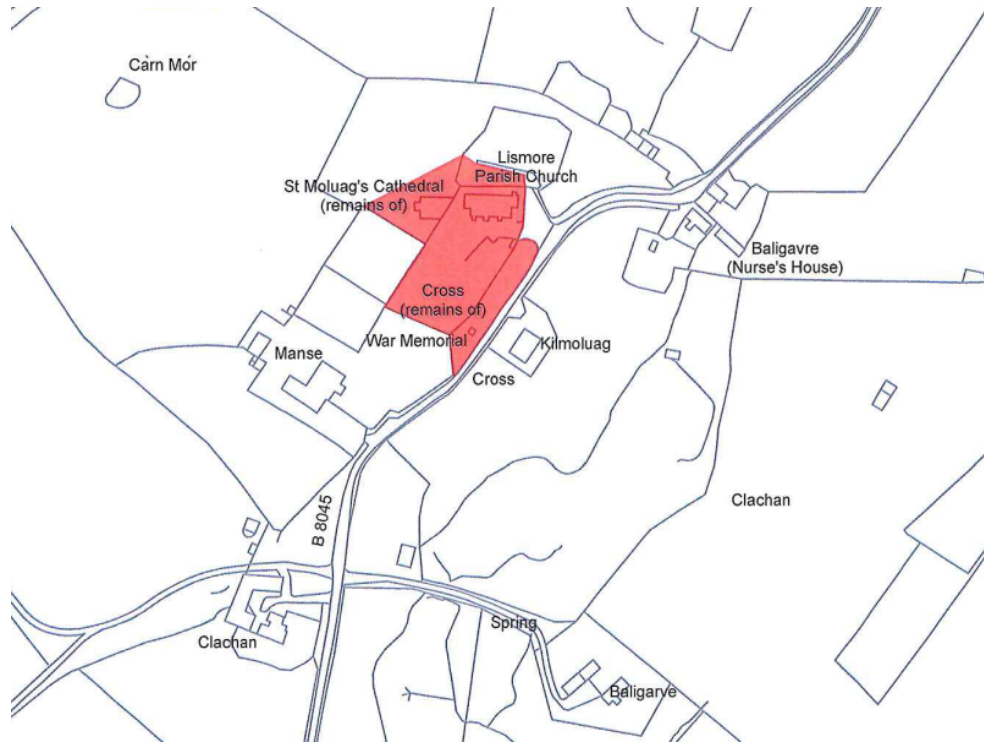
Fig 2: Extract of map from schedule SM no. 286.

Lismore Parish Church is a category B listed building. The ruins of St Moluags cathedral are a scheduled ancient monument (SM 286) and includes the church building below floor level and the wider site (fig. 2).

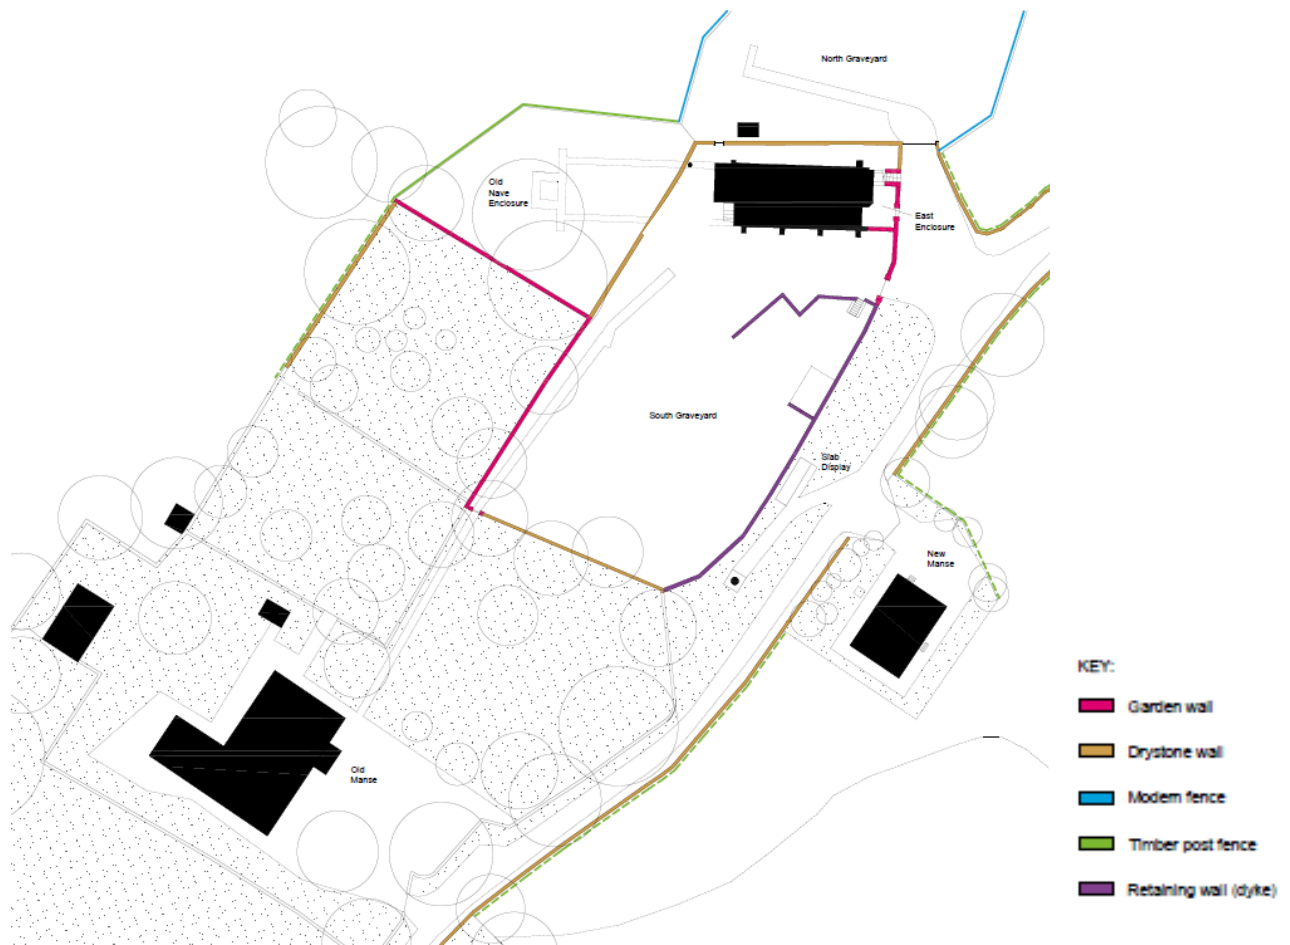
Fig 3: Site plan showing enclosure and boundary walls.

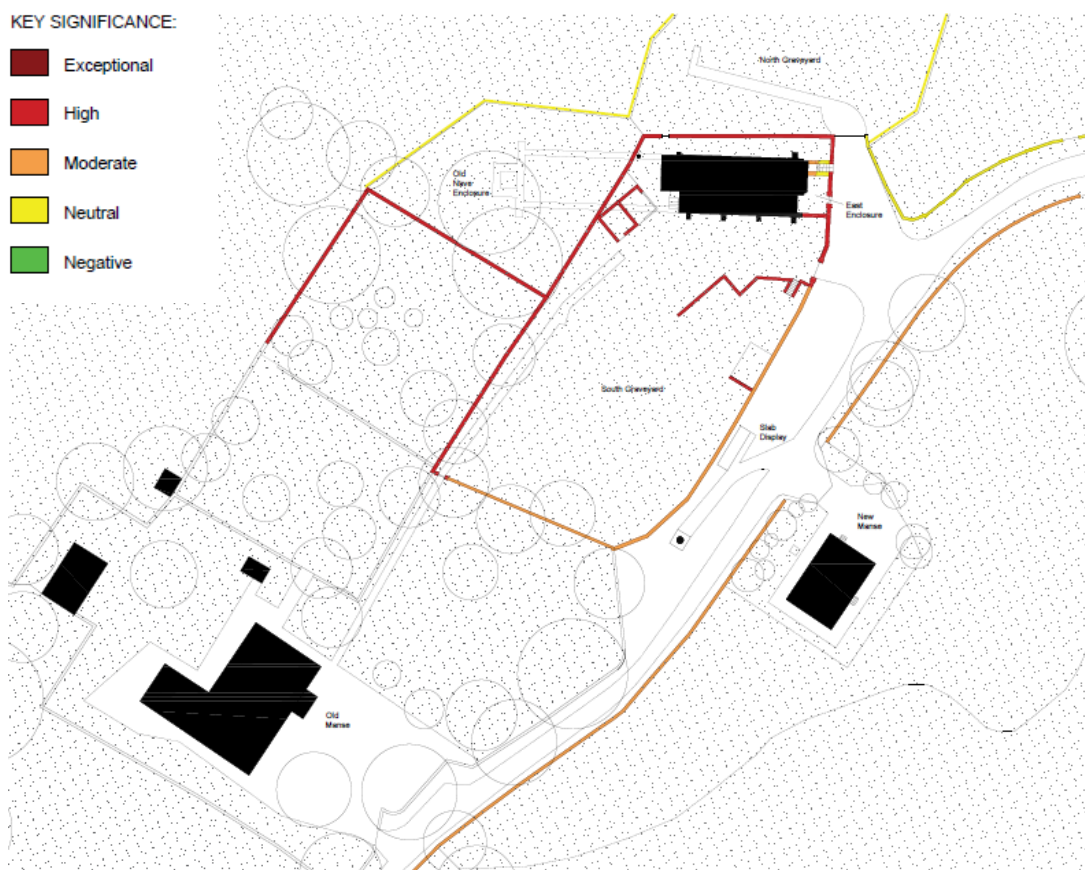
Fig. 8: Significance of Enclosures and Boundaries

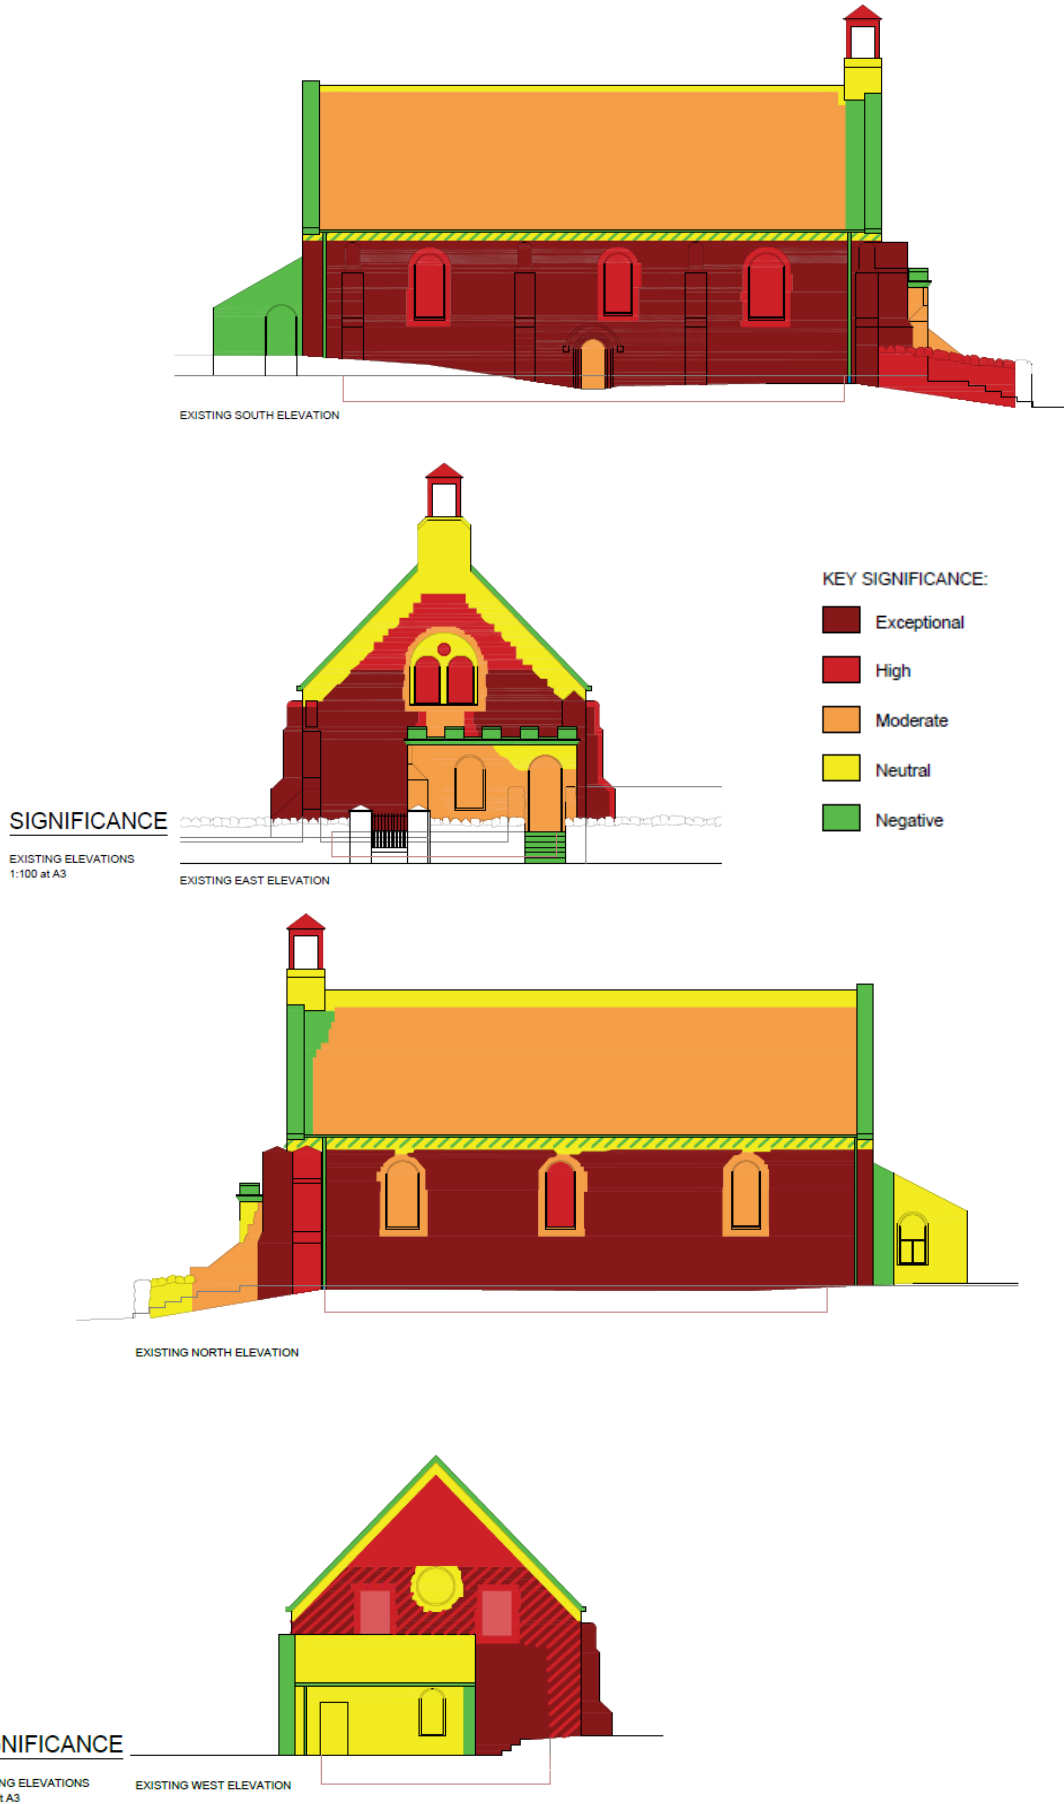
Fig. 11: Significance of Elevations
